Flood Proofing Systems & **Techniques**

Examples of flood proofed structures in the United States

US Army Corps of Engineers

December 1984

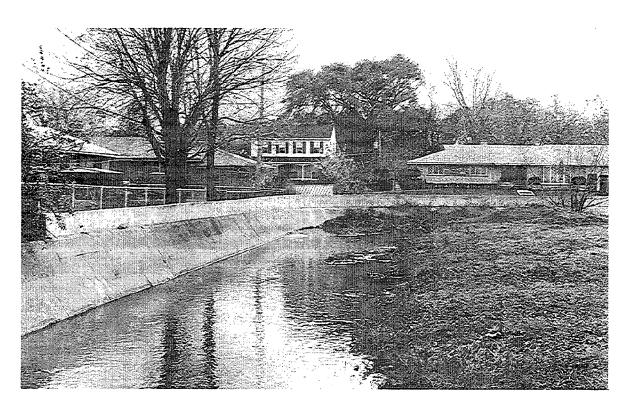
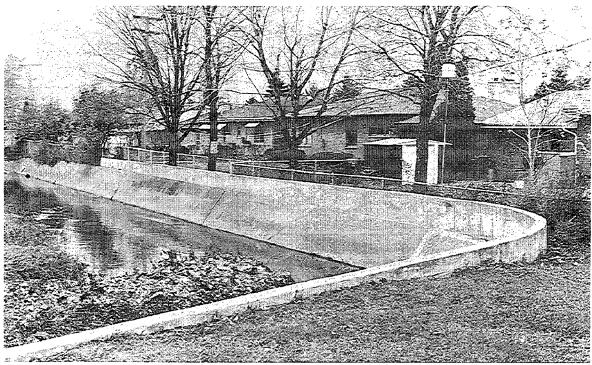
Figure A37. Floodwall and retaining wall built to protect homes

Leyden Township Flood Wall, Leyden Township, Illinois This floodwall was built in 1975 to protect three single-story ranch homes from flooding from Silver Creek. The poured concrete floodwall is approximately 210 feet long, 8 inches wide, and 5.5 feet high (2 feet of which is above ground). The floodwall is entrenched in the ground behind a concrete retaining wall designed to prevent erosion along the creek (Figure A37). The 1975 cost of constructing the flood wall was \$2940. An additional \$5760 was spent at that time for constructing 120 feet of retaining wall, for a total cost of \$8700.

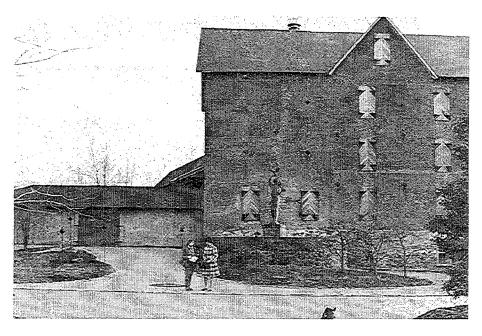
General view of original building.

Figure A39. Flood proofed museum

Due to its location adjacent to the Brandywine River and the Old Mill Race, the structure is subject to overbank flooding which has been known to reach 4 feet deep at times. Flooding has occurred seven or eight times in the last few years and has lasted several hours each time. To protect the lower levels of the building from flooding, doors have been fitted with 3/8-inch removable aluminum shields. The shields along with portable pumps are installed during times of predicted high water. Neoprene seals have been built into the lecture room floor (ground level) and flanged up the wall 18 inches above the floor. Lag bolts for doors are built into the door frames to assure a tight fit. Butyl caulking is placed around the shield for extra seal. The sump pumps are installed in elevator wells to eliminate water seepage that cannot otherwise be controlled. Any seepage around the flood shields is handled by shop-vacs.

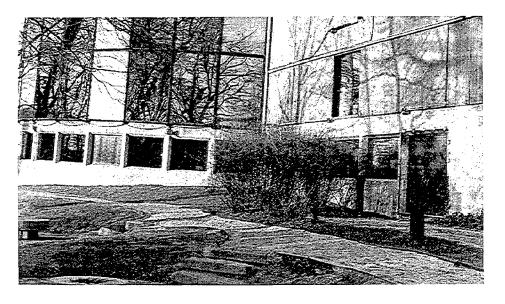
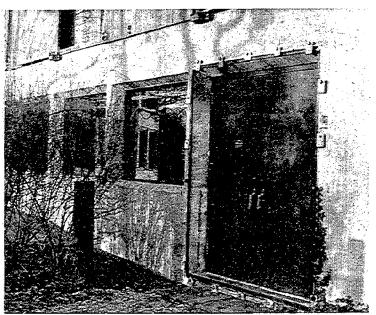
Figure A39.

ABOVE: General view. Note flood proofed door at right.

RIGHT: Closeup of door framing and latch devices for flood shield.

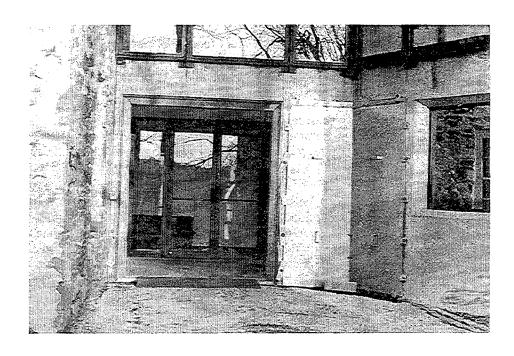
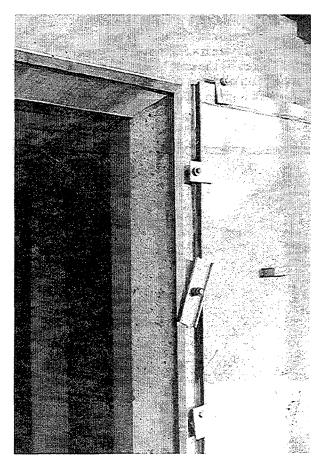
ABOVE: Closure for door in stored position.

LEFT: Closeup view of shield, framing, and latch devices.

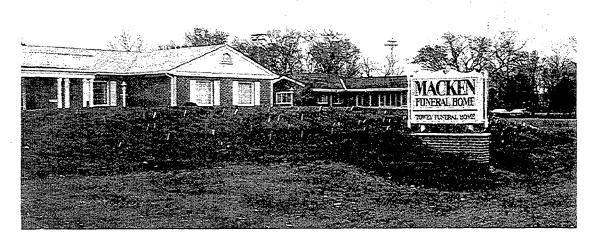
Earthern berm in front of building.

Figure A40. Funeral home with flood barriers, bricked lower windows, and debris protection berm

This single-story funeral home (Figure A40) is presently made up of two parts—the original section built in 1962 with a first floor of wood construction with a crawl space beneath, and a new addition added in 1982 which is a concrete slab on grade. The walls are concrete block with a brick veneer. The structure is susceptible to flooding from Bear Creek. The last flood, in the summer of 1978, was of relatively short duration (3 to 4 hours) but put about 2 feet of water on the first floor. Flow velocities during that flood were great, although overall flood damage to the structure was minimal.

- The lower portions of windows were bricked up.
- Aluminum flood barriers were built for use over door openings.
- A 3- to 4-foot-high berm was constructed in front of the building to protect it from floating debris.
- A secondary sewer backup valve was installed.

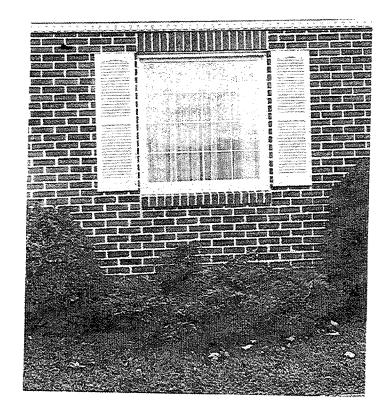
Window to right of main entrance. Bottom portion of window replaced with brick. Windows now above regional flood level.

The owner believes the system should be effective. By bricking in the bottom portion of the windows to an elevation above the regional flood level and installing the flood barriers, seepage and flooding should be prevented. The berm may not have been required, but should provide additional protection in the event that floodflows come from another direction. If the system is implemented as designed, the building and contents should be protected from all flood damages up to the regional flood level.

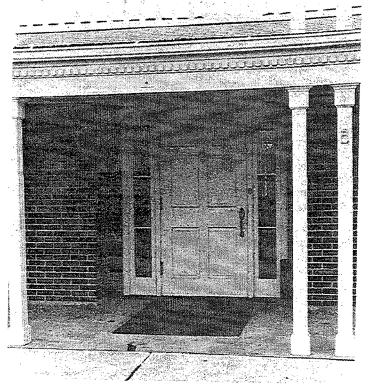
Figure A40.

Main entrance. Aluminum closures designed for placement in doorway.

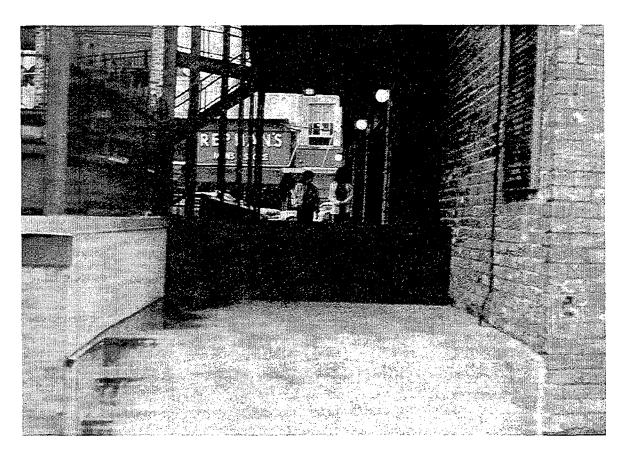
Figure A41. Brick building with sealed walls, flood barriers, and raised windows

Two-story brick building with sealed walls, flood barriers, and raised windows, Hot Springs, Arkansas Two two-story buildings of brick construction were connected to make a commercial complex containing specialty shops and a restaurant. At a cost of approximately \$5000, the basement and first floor walls were sealed, windows on the first floor were raised above the 100-year flood elevation, and exterior doorways were closed and sealed, except for one doorway which was fitted with a removable flood shield made of 3/4-inch plywood (Figure A41). The effectiveness of the flood shield is questionable, since no seals are to be used around its edges and no reinforcement is present to stiffen the shield or to lock it in place. No floods have occurred since construction to test the system.

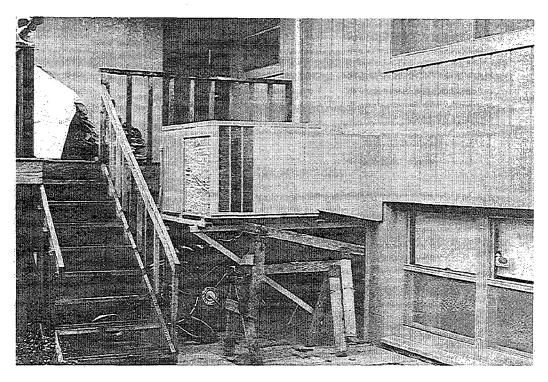
Figure A42. Single-family house with raised heating-cooling and electrical equipment.

This single-family house located near the Zumbro River in Rochester, Minnesota, has its heating, cooling, and electrical equipment raised on the outside of the house above the regional flood level. The utilities are built on a platform supported by steel supports that are attached to the house (Figure A42). Cost to raise the utilities was minimal—perhaps \$1000. A sewer backup valve has also been installed and proved effective during the 1978 flood. At that time, flooding lasted 9 to 10 hours and reached a depth of 3 feet. The basement of the house was flooded, and if the utilities had been located there, they would have been damaged or perhaps destroyed.

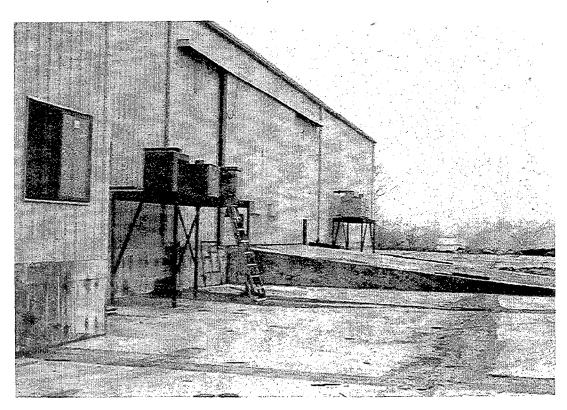
Elevated exterior equipment.

Figure A43. Warehouse with raised electrical/mechanical equipment

During flooding, the area has been known to remain inundated for as long as 26 days. Electrical/mechanical equipment submerged for this length of time would almost certainly be ruined. Exterior equipment was placed on steel platforms accessible by portable ladders; interior electrical control panels were mounted on interior walls accessible by steel stairs (Figure A43).

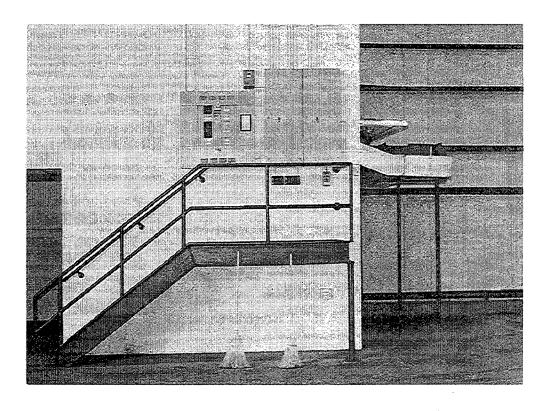
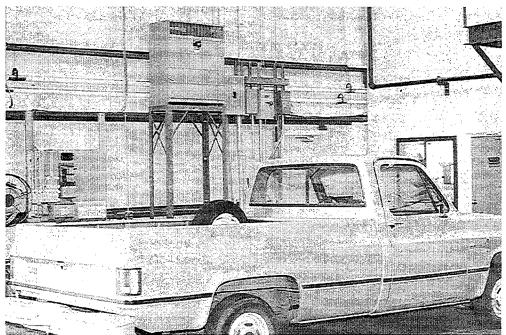
Figure A43.

Elevated interior equipment

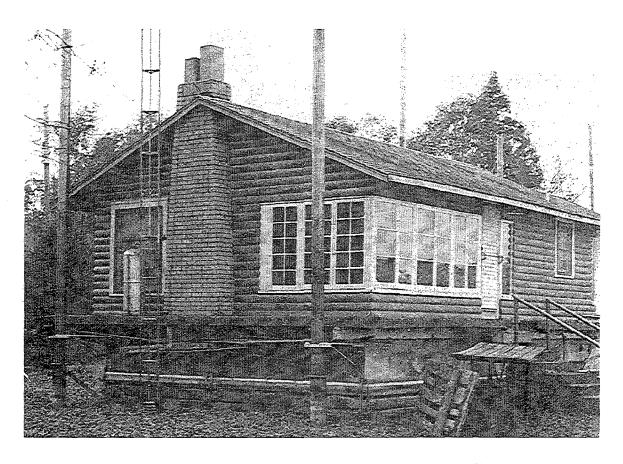
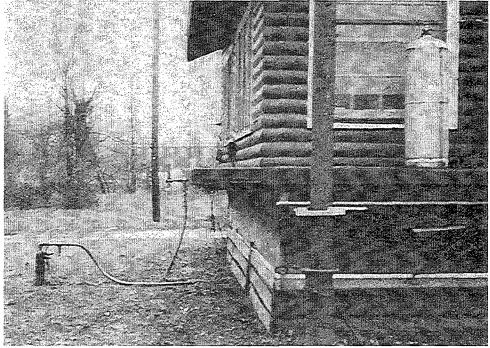
Figure A44. One-story house mounted on barge-like flotation system

One-story house mounted on a bargelike flotation system, Ouachita River, Arkansas Flooding from the Ouachita River in the vicinity of this structure occurs on an almost annual basis and can last from several weeks to 6 months. Damage to a structure inundated this frequently and for this length of time could be devastating. To avoid such a dilemma, this one-story conventional frame house was mounted on a barge-like flotation system attached by collars to four metal guide pylons anchored in the ground at each corner (Figure A44). When the area is not flooded, the barge rests on a concrete foundation that is hidden by wooden aprons attached to the sides of the barge. When flooding occurs, the structure rises vertically with the water, guided by the pylons. Water and sewage hookups are made of flexible pipe and are serviceable during flooding. The estimated cost of flood proofing is \$6000.

This system of flood proofing appears to work well in areas of relatively deep flooding of long duration with nondamaging flow velocities. During the 1973 flood, floodwaters reached 15 feet in depth with no failure to the system. Aside from the relatively high cost of the system, however, is the fact that maintenance is required to keep the barge apparatus from deteriorating. The owner indicated that if he were to build again, he would likely use styrofoam pontoons in lieu of the metal barge.

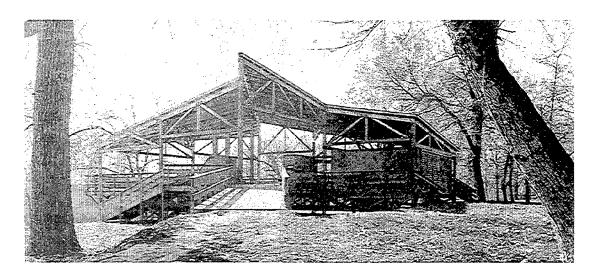
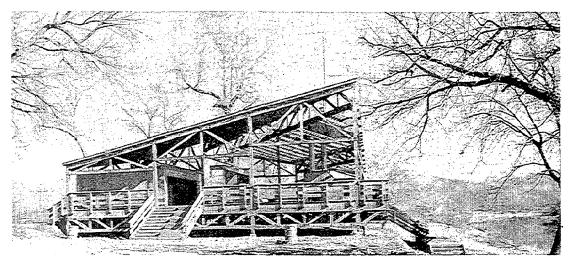
Figure A45. Park pavilion built of flood damage-resistant materials

This park pavilion was built in the Meramac River flood plain only a few feet from the high bank of the river using flood damage-resistant materials. It was designed by students of Washington University for location in a flood hazard area and is built of treated wood. The foundation consists of wood posts bolted to low-level concrete piers. The floor is elevated 3 to 6 feet above natural ground. It is an open structure (without walls) designed to allow floodwaters to pass through with little resistance (Figure A45), thus reducing the chance of damage to the structures. During the spring 1979 flood, the structure was inundated for several days, yet no damage was sustained. It thus represents an ideal structure for use in flood-prone areas such as parks adjacent to rivers.

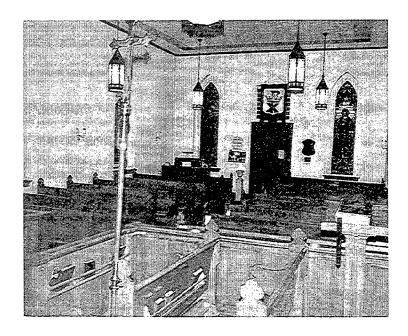
Figure A46.

Inside view of church. Basement ceiling showing bolts.

All floor-mounted fixtures, such as the altar, pews, altar rails, and choir screen, are bolted through the floor where they are secured in the basement with washers and wing nuts (Figure A46). Wall-mounted fixtures are fastened by means of cabinet hangers. All such items can be quickly disconnected and

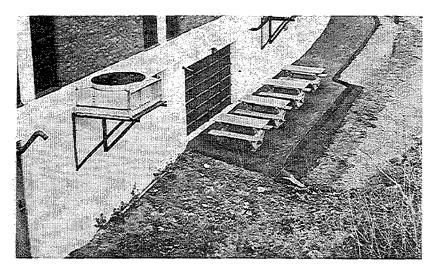
Curtain walls, exterior openings, and wall connections reinforced with steel angle bracing.

u	framing members reinforced with steel angle bracing members at the subbasement level to resist exterior water loads.
	Curtain wall at rear elevation of subbasement and mechanical room reinforced with backup column or pilaster of block to resist exterior water loading.
	Damageable supplies previously stored in the subbasement removed to higher floors for storage.
	Electric sump pump (1-inch) installed in building elevator shaft (sump).
	Rubber stoppers or plugs secured for installation in floor drains during periods of high water.
	Steel plate closure panels or bulkheads and support members fabricated for the garage door opening at the rear subbasement level to minimize water seepage and door and interior damages.
	Two exterior personnel doors at rear subbasement level fitted for temporary sealing using panels and sandbags to minimize seepage.
	Planned removal during high water of the two air exchange fan units at the rear of the building at ground level.

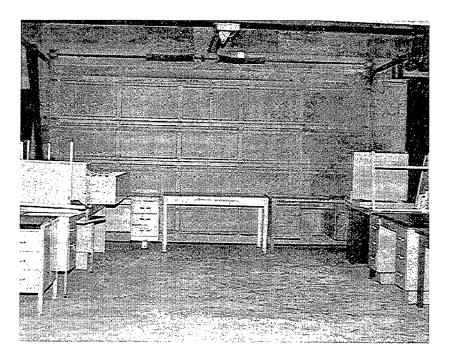
Supplies previously stored in subbasement were moved to higher floors.

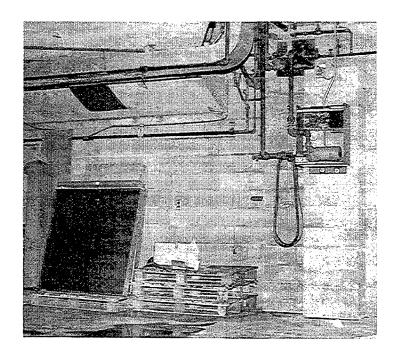
ABOVE: Critical electrical and mechanical panels, switches, and control boards were relocated to a higher level.

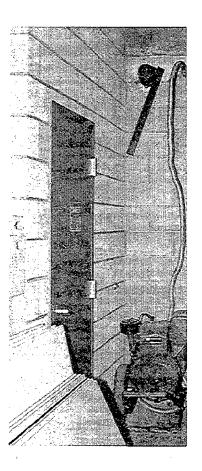
Figure A47.

RIGHT: Electric pump was installed in the elevator shaft.

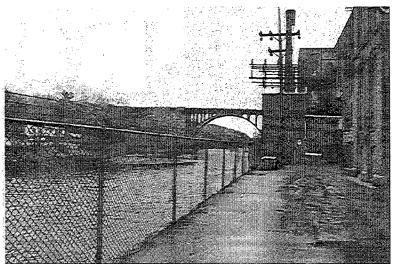
2. Looking upstream on Blackstone River. Note substation location.

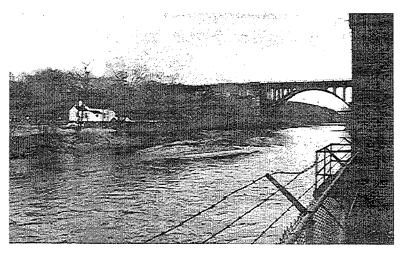
3. Note deposition of riverbank washout material in river, reducing conveyance.

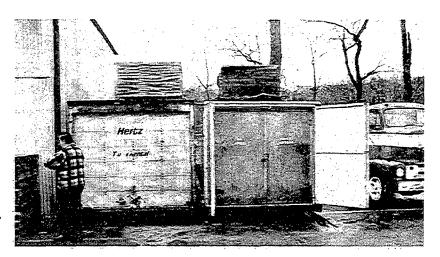
5. Flood control equipment storage shed, masterlocked for security.

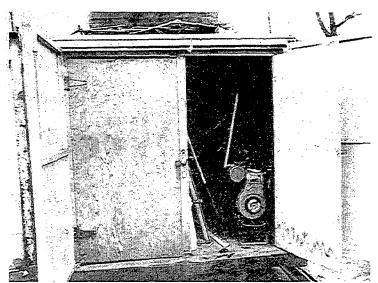
6. Shed open—note pump.

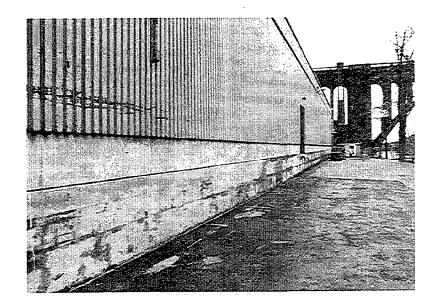
7. Finished product warehouse was under construction when 1955 flood hit. Floor grade was subsequently raised by 4 feet.

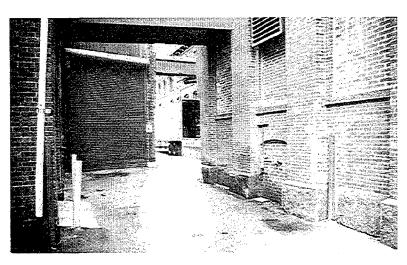
9. Outside flood control station:
(1) foreground is allowed to flood,
(2) background is protected by
stoplogs in vertical channels, and
(3) note two pump exit ports (electric & steam syphon) at former window which has been bricked.

In addition to these active flood proofing techniques, permanent measures have been taken to prevent flood damages. Nonessential windows and openings have been bricked up, the electrical switching station has been surrounded by concrete walls, storage tanks have been anchored and surrounded by concrete walls, and the three sewage pumping stations located within the facility have been completely enclosed. Bulkheads were built in the basement to isolate floodwaters to certain areas should the external closures fail. Interior drainage, from roofs, and seepage has been routed to multiple-sump discharge points.

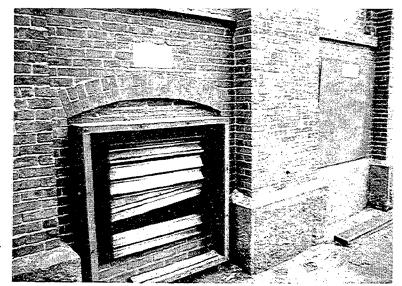
10. Vent opening and nearby cover. Bolts are inspected, loosened, and lubricated periodically (2 or 3 times per year)

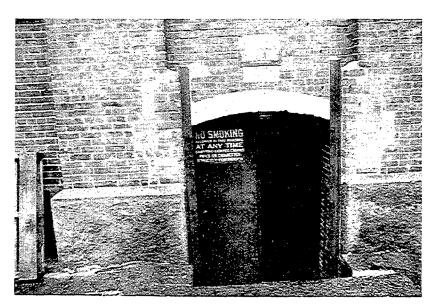
11. Building door with closure fittings.

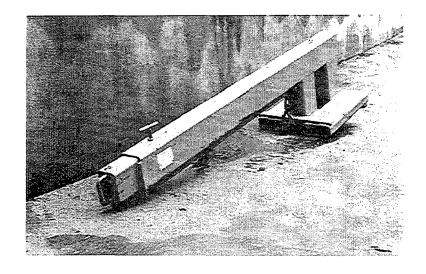
13. Specially fabricated extension for forklift allows sufficient reach to extract electrical motors.

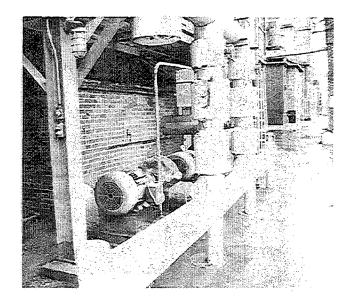
14. Motors located in flood area:
(1) characterized by quick disconnect
mounts & electrical connections, and
(2) note rings on top for fork lift
pickup.

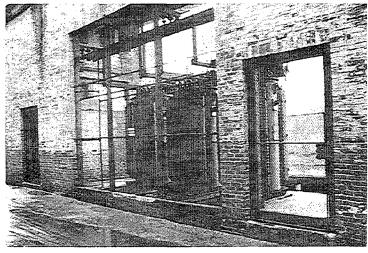
15. Electrical substation: lip offers protection for higher frequency, lower stage flooding.

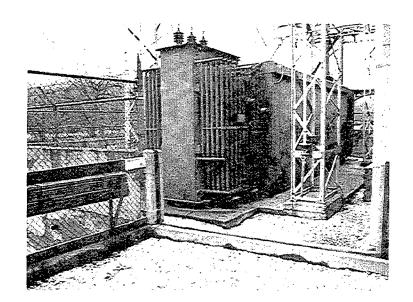
16. Another substation: (1) note closure fittings and stoplogs stored nearby, (2) note drain for normal rainfall, and (3) during flood, interior drainage is pumped.

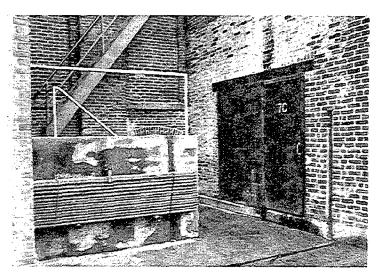
17. Stoplog panels stored close to point of usage.

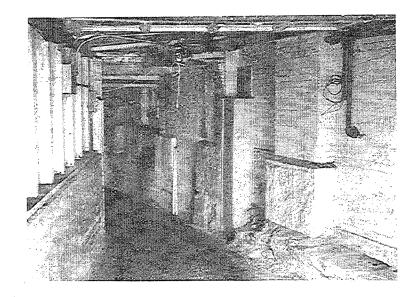
19. Main basement entrance & closure point.

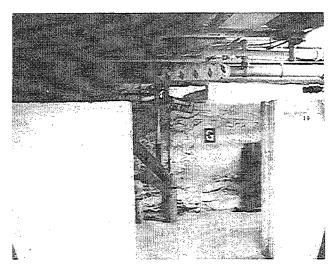
20. Interior bulkhead: (1) if exterior closures fail, water is held to the foreground area, and (2) note "Flood Control Station 14" notation. This type of marking is used throughout, and ties in with flood-fighting procedural steps, as well as "dry-run" procedures.

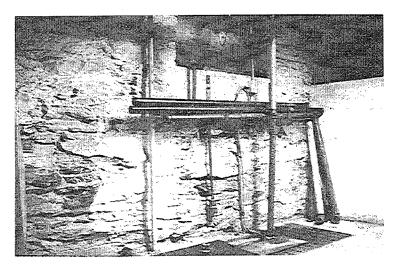
21. Basement sump: (1) discharge pipe shown is attached to electrically operated pump, triggered by float switch; (2) in event of failure or lack of capacity, standby pipes are connected to a steam syphon; and (3) note stone foundation, allowing a certain amount of seepage.
